Sacramento River, RM 77.2L

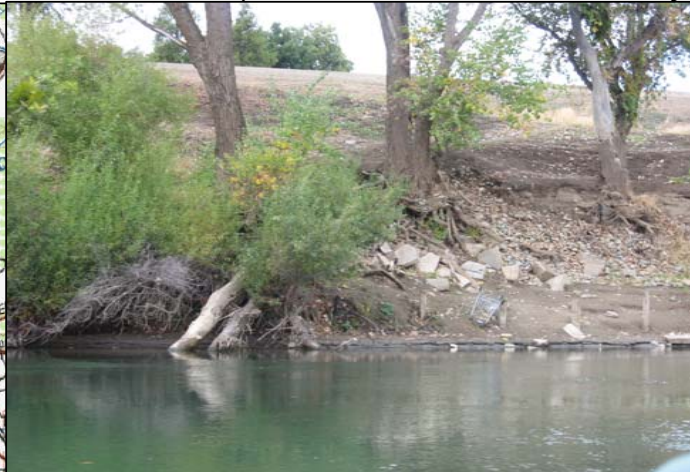
Site Photograph

Criteria	Score	Notes
Bank Slope (*2)	4	1:1 slope
Berm Width (*2) - Estimated	5	0 to 10 ft of berm
Length of erosion	4	1260ft
Location of erosion	4	toe and lower slope
Bank Stability	5	vertical sections, less than half bank height, and caves
Radius of Curvature (R_c/w)	0	relatively straight
Site Relative to Bend	1	relatively straight
Geomorph	2	some migration possible on opposite bank
Vegetation Cover	1	70% veg cover
Tree Hazard	5	large trees with exposed roots, some leaning
Soil Type (*2)	4	sands and silts
Velocity (*2)	3	4.03 ft/s
Wave Action (Wind/Boat)	3	near boat launch, recreational boating and fishing
Economic Factor (*2)	4	Yuba City
Human Usage	5	daily, paths and garbage
Seepage Potential	0	no known seepage history
Tidal Fluctuation	0	no tidal influence

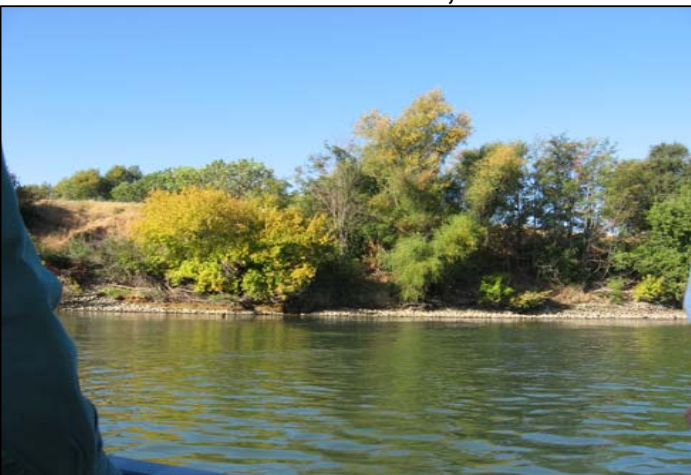
Site Photograph

Criteria	Score	Notes
Bank Slope (*2)	3	1.5:1 slope
Berm Width (*2) - Estimated	5	0 to 10 ft
Length of erosion	2	300 ft
Location of erosion	4	toe and lower bank
Bank Stability	5	vertical sections and caves
Radius of Curvature (R_c/w)	1	$R/w = 4.9$
Site Relative to Bend	0	inside of a bend
Geomorph	0	tight levees, no migration possible
Vegetation Cover	1	70%
Tree Hazard	5	large trees, exposed roots and leaning
Soil Type (*2)	4	sands and silts
Velocity (*2)	4	5.16 ft/s
Wave Action (Wind/Boat)	4	heavy boating area
Economic Factor (*2)	4	West Sacramento
Human Usage	4	weekly
Seepage Potential	0	no know seepage history
Tidal Fluctuation	2	roughly 2 ft of tidal flux

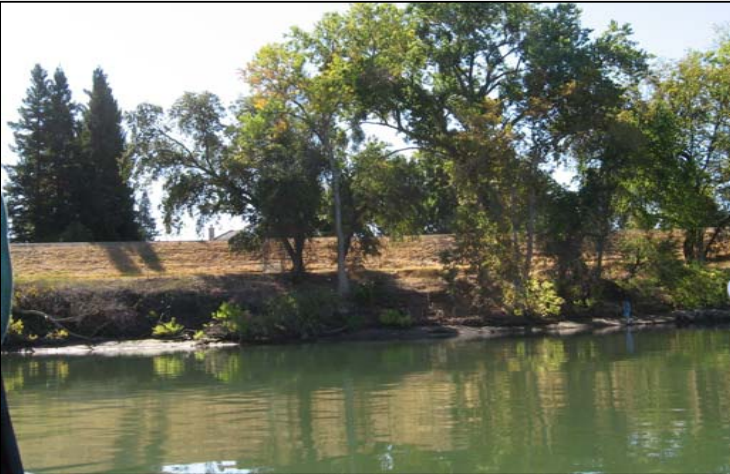
Site Photograph

Criteria	Score	Notes
Bank Slope (*2)	3	1.5:1
Berm Width (*2) - Estimated	3	5 to 10 ft
Length of erosion	3	1000 ft
Location of erosion	4	toe, lower bank, and berm
Bank Stability	3	cave, greater than 4 ft
Radius of Curvature (R_c/w)	0	straight
Site Relative to Bend	1	straight
Geomorph	0	no migration possible
Vegetation Cover	2	60%
Tree Hazard	5	trees with some exposed roots and leaning
Soil Type (*2)	4	sands and silts
Velocity (*2)	4	5.97 ft/s
Wave Action (Wind/Boat)	4	heavy recreational boating area
Economic Factor (*2)	5	Sacramento
Human Usage	5	daily
Seepage Potential	0	no seepage
Tidal Fluctuation	2	about 2 ft of tidal flux

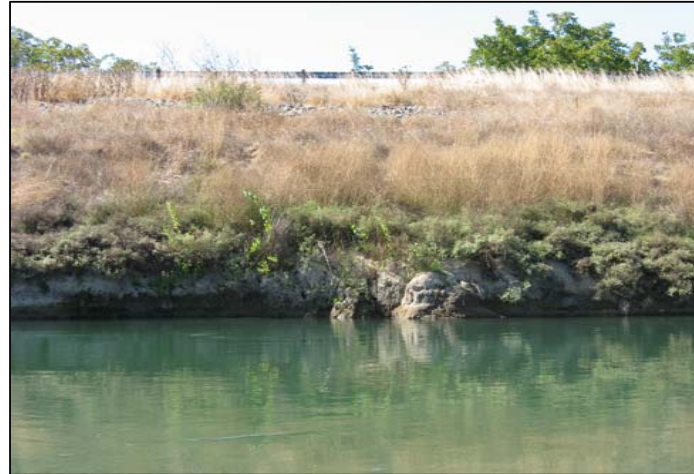
Site Photograph

Criteria	Score	Notes
Bank Slope (*2)	3	1.5:1 slope
Berm Width (*2) - Estimated	5	no berm
Length of erosion	4	1005 ft
Location of erosion	4	upper bank and toe
Bank Stability	2	vertical sections, less than half bank height, 40 to 50 ft scour hole
Radius of Curvature (R_c/w)	4	$R/w = 1.33$ (bend has migrated down from what is shown on the map)
Site Relative to Bend	5	outside of a less than 90 degree bend
Geomorph	2	migration possible on opposite bank
Vegetation Cover	2	60%
Tree Hazard	2	2 medium trees
Soil Type (*2)	2	clays and silts
Velocity (*2)	4	5.27 ft/s
Wave Action (Wind/Boat)	2	low
Economic Factor (*2)	3	rural town of Willows
Human Usage	5	adjacent to road, next to a pump intake, daily use
Seepage Potential	0	no seepage history
Tidal Fluctuation	0	no tidal influence

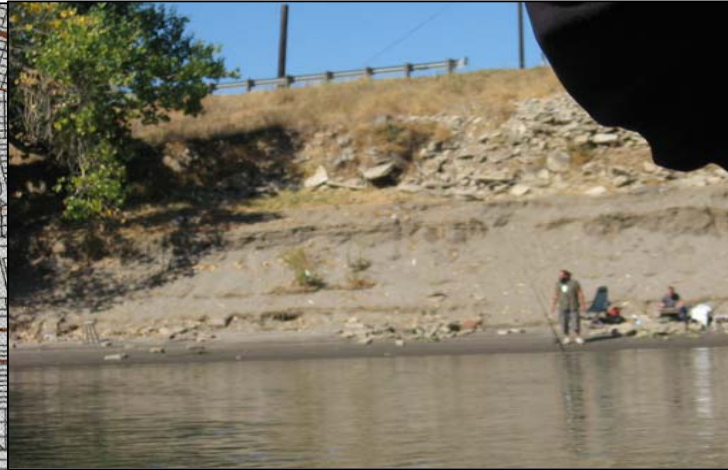
Site Photograph

Criteria	Score	Notes
Bank Slope (*2)	4	1:1 slope
Berm Width (*2) - Estimated	3	5 ft of berm
Length of erosion	2	402 ft
Location of erosion	4	whole bank and toe
Bank Stability	2	small vertical sections
Radius of Curvature (R_c/w)	3	$R/w = 2.7$
Site Relative to Bend	0	inside of a bend
Geomorph	0	no migration possible
Vegetation Cover	2	50%
Tree Hazard	4	large trees with exposed roots
Soil Type (*2)	4	sand and silts
Velocity (*2)	4	6.02 ft/s
Wave Action (Wind/Boat)	4	big boating recreation area
Economic Factor (*2)	4	West Sacramento
Human Usage	5	daily, parking area on levee, paths down, debris
Seepage Potential	0	no known seepage history
Tidal Fluctuation	2	2 ft of tidal flux

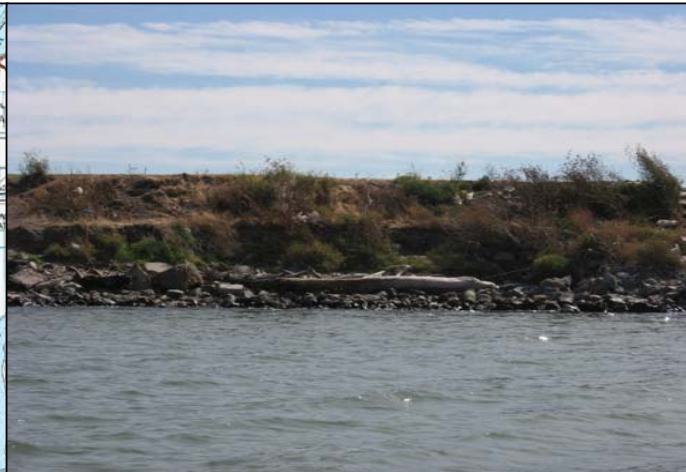
Site Photograph

Criteria	Score	Notes
Bank Slope (*2)	5	near vertical
Berm Width (*2) - Estimated	5	no berm
Length of erosion	3	757 ft
Location of erosion	2	levee slope
Bank Stability	4	vertical for more than half bank height
Radius of Curvature (R_c/w)	1	$R/w = 4.54$
Site Relative to Bend	3	outside of a greater than 90 degree bend
Geomorph	0	no migration expected
Vegetation Cover	2	40 to 50 %
Tree Hazard	0	no trees
Soil Type (*2)	4	sands and silts
Velocity (*2)	4	5.13 ft/s
Wave Action (Wind/Boat)	4	heavy winds
Economic Factor (*2)	1	Farms
Human Usage	4	adjacent to road, weekly
Seepage Potential	0	no history of seepage
Tidal Fluctuation	5	5 ft of tidal flux

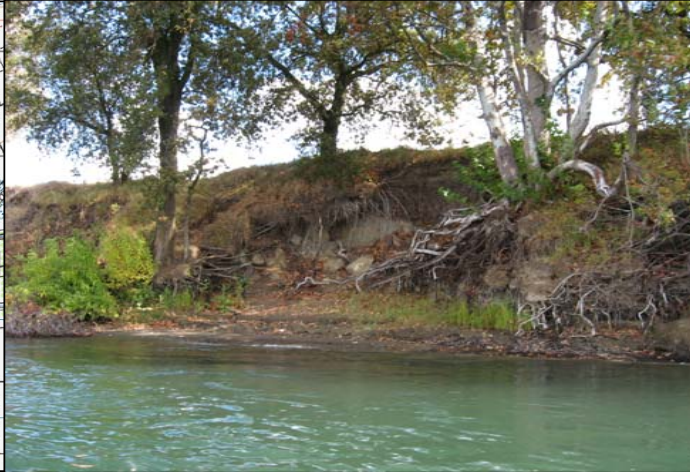
Site Photograph

Criteria	Score	Notes
Bank Slope (*2)	4	1:1 slope
Berm Width (*2) - Estimated	0	50 ft
Length of erosion	2	407 ft
Location of erosion	3	whole bank
Bank Stability	4	vertical sections for whole bank height
Radius of Curvature (R_c/w)	2	$R/w = 3.11$
Site Relative to Bend	5	outside of a slightly less than 90 degree bend
Geomorph	5	channel migration possible on both sides
Vegetation Cover	2	about 40 to 50%
Tree Hazard	5	large trees, roots exposed, and leaning
Soil Type (*2)	4	sands and silts
Velocity (*2)	3	4.63 ft/s
Wave Action (Wind/Boat)	2	only accessible to small boats, low wave action
Economic Factor (*2)	4	The community of Plumis Lake
Human Usage	1	Dumping spot but not much usage
Seepage Potential	5	seepage history
Tidal Fluctuation	0	no tidal flux
Erosion Hazard	66	Calculate Erosion Hazard

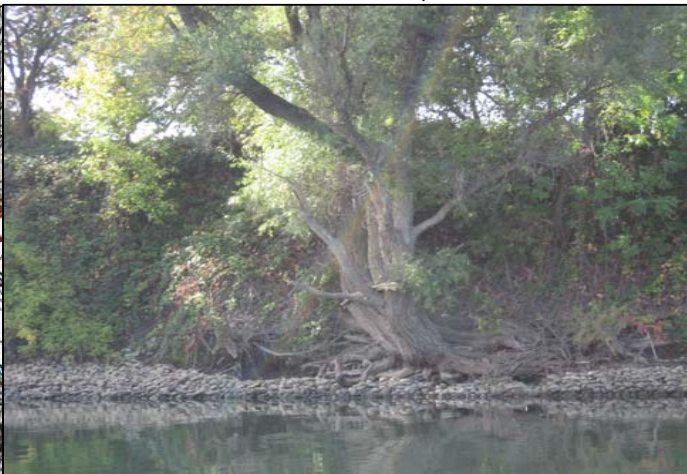
Site Photograph

Criteria	Score	Notes
Bank Slope (*2)	4	1:1 slope
Berm Width (*2) - Estimated	2	10 to 20 ft
Length of erosion	2	280 ft
Location of erosion	4	whole bank and toe
Bank Stability	5	caves greater than 4 ft and vertical sections
Radius of Curvature (R_c/w)	0	$R/w = 6.43$
Site Relative to Bend	2	just downstream of a bend
Geomorph	0	no migration expected
Vegetation Cover	2	50 -60%
Tree Hazard	5	trees with exposed roots, some leaning
Soil Type (*2)	4	sands and silts
Velocity (*2)	3	3.39 ft/s
Wave Action (Wind/Boat)	3	moderate waves, speed limit of 5mph
Economic Factor (*2)	5	Sacramento
Human Usage	5	Debris and paths indicative of daily use
Seepage Potential	0	no seepage history
Tidal Fluctuation	0	no tidal effect

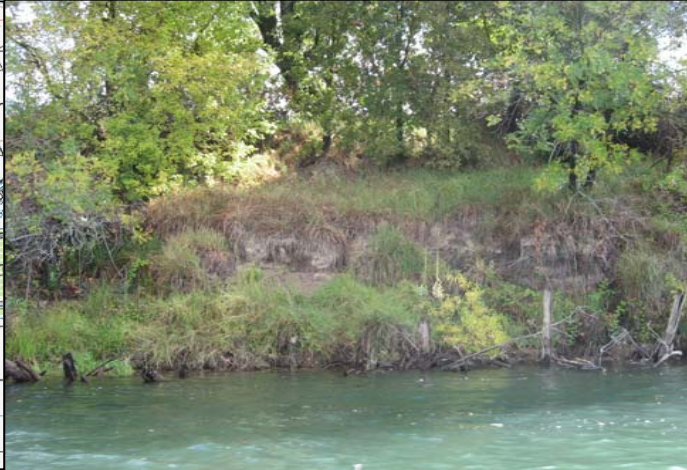
Site Photograph

Criteria	Score	Notes
Bank Slope (*2)	4	1:1 slope or less
Berm Width (*2) - Estimated	0	50 ft
Length of erosion	2	307 ft
Location of erosion	4	whole bank and toe
Bank Stability	5	caves, greater than 4 ft and vertical sections
Radius of Curvature (R_c/w)	0	$R/w = 6.04$
Site Relative to Bend	3	outside of a greater than 90 degree bend
Geomorph	2	migration possible on opposite bank
Vegetation Cover	3	40 to 50%
Tree Hazard	5	large trees with exposed roots and trees sliding down the bank
Soil Type (*2)	4	sands and silts
Velocity (*2)	4	5.34 ft/s
Wave Action (Wind/Boat)	2	accessible only to small boats
Economic Factor (*2)	4	near the community of Plumis Lake
Human Usage	1	rather steep, not too accessible, occassional
Seepage Potential	5	history of seepage
Tidal Fluctuation	0	no tidal flux
Erosion Hazard	64	Calculate Erosion Hazard

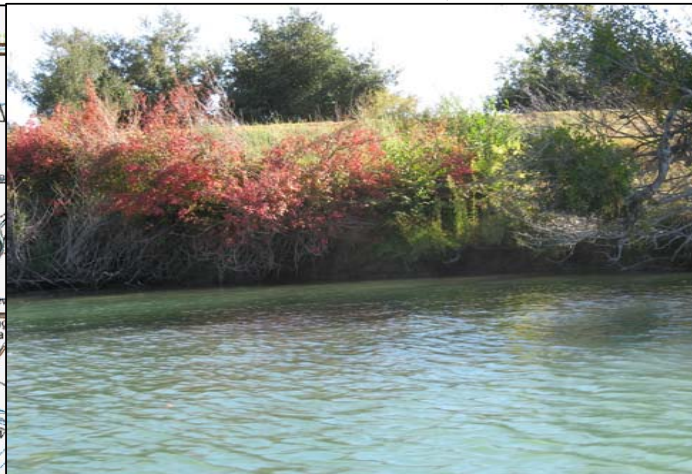
Site Photograph

Criteria	Score	Notes
Bank Slope (*2)	4	1:1 or less
Berm Width (*2) - Estimated	5	0 to 50 ft
Length of erosion	5	1547 ft
Location of erosion	5	bank, toe, and underwater
Bank Stability	4	vertical sections, greater than half bank height
Radius of Curvature (R_c/w)	0	straight
Site Relative to Bend	1	straight
Geomorph	0	no migration possible
Vegetation Cover	1	70 to 80%
Tree Hazard	4	trees with exposed roots
Soil Type (*2)	2	clays and silts
Velocity (*2)	4	5.13 ft/s
Wave Action (Wind/Boat)	4	just downstream of a marina
Economic Factor (*2)	2	small town of Isleton
Human Usage	1	occassional
Seepage Potential	0	no seepage history
Tidal Fluctuation	4	4 ft of tidal flux

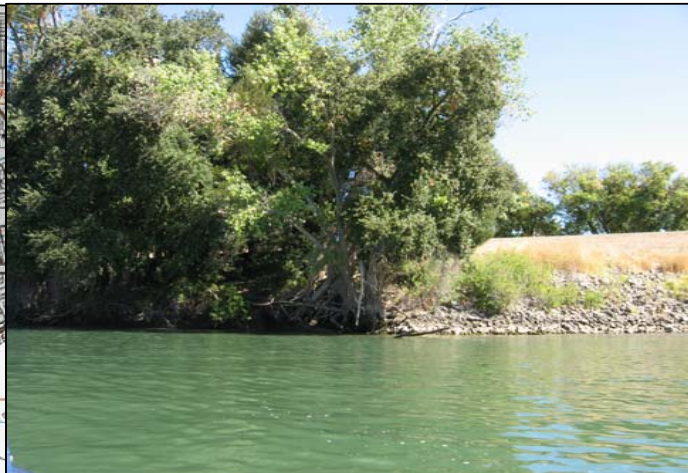
Site Photograph

Criteria	Score	Notes
Bank Slope (*2)	3	1.5:1 slope
Berm Width (*2) - Estimated	2	10 ft of berm
Length of erosion	1	100 ft
Location of erosion	5	bank, toe, and underwater
Bank Stability	2	some small vertical sections
Radius of Curvature (R_c/w)	0	straight
Site Relative to Bend	1	straight
Geomorph	0	no migration possible
Vegetation Cover	1	60%
Tree Hazard	4	large trees with exposed roots
Soil Type (*2)	5	silts
Velocity (*2)	4	5.6 ft/s (UNET)
Wave Action (Wind/Boat)	4	heavy, recreational boating area
Economic Factor (*2)	5	Sacramento
Human Usage	4	bike path on top, weekly
Seepage Potential	0	no history of seepage
Tidal Fluctuation	2	2 ft of tidal flux
Erosion Hazard	62	Calculate Erosion Hazard

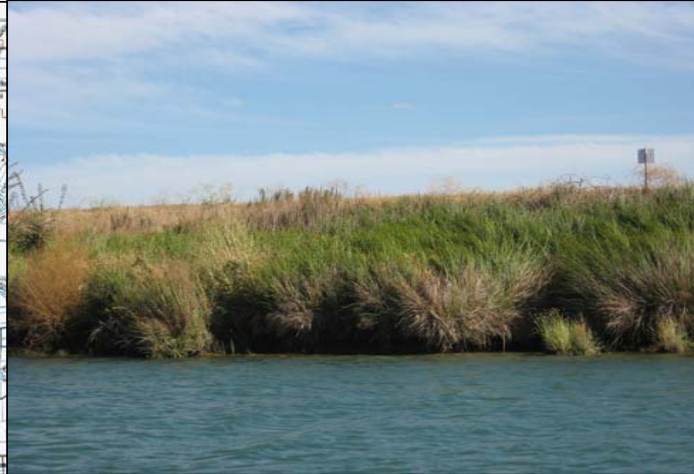
Site Photograph

Criteria	Score	Notes
Bank Slope (*2)	3	1.5:1 or less
Berm Width (*2) - Estimated	4	less than 5 ft
Length of erosion	5	3071 ft
Location of erosion	5	levee slope, toe and underwater
Bank Stability	5	vertical sections and caves
Radius of Curvature (R_c/w)	0	$R/w = 7.52$
Site Relative to Bend	3	outside of a gentle bend
Geomorph	0	no migration possible
Vegetation Cover	1	70% cover
Tree Hazard	4	large trees with exposed roots
Soil Type (*2)	4	sands and silts
Velocity (*2)	3	3.95 ft/s
Wave Action (Wind/Boat)	3	moderate boat wake
Economic Factor (*2)	1	Farms
Human Usage	2	seasonal
Seepage Potential	0	no seepage history
Tidal Fluctuation	4	4 ft of tidal flux

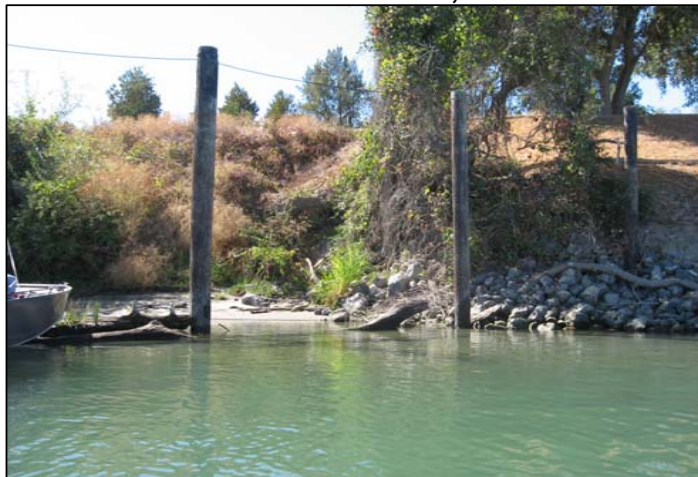
Site Photograph

Criteria	Score	Notes
Bank Slope (*2)	3	1.5:1 slope
Berm Width (*2) - Estimated	5	no berm
Length of erosion	1	100 ft
Location of erosion	4	toe and lower bank
Bank Stability	2	vertical sections, less than half bank height
Radius of Curvature (R_c/w)	0	straight
Site Relative to Bend	1	straight
Geomorph	0	tight levees, no migration
Vegetation Cover	1	60 to 70 %
Tree Hazard	5	large trees, exposed roots, and leaning
Soil Type (*2)	4	sands and silts
Velocity (*2)	4	5.36 ft/s
Wave Action (Wind/Boat)	3	moderate
Economic Factor (*2)	2	small town of Clarksburg
Human Usage	5	daily
Seepage Potential	0	no seepage history
Tidal Fluctuation	3	3 ft of tidal flux
Erosion Hazard	61	Calculate Erosion Hazard

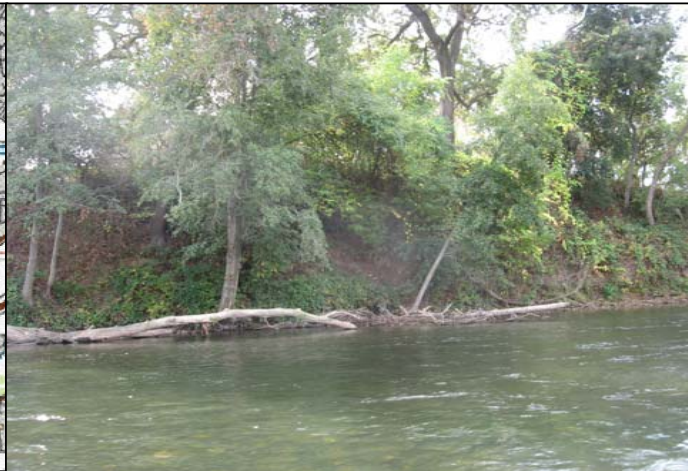
Site Photograph

Criteria	Score	Notes
Bank Slope (*2)	5	near vertical
Berm Width (*2) - Estimated	2	15 to 20 ft
Length of erosion	2	136 ft
Location of erosion	2	whole bank
Bank Stability	5	tree popouts and vertical sections
Radius of Curvature (R_c/w)	0	straight
Site Relative to Bend	1	straight
Geomorph	0	no migration expected
Vegetation Cover	1	80%
Tree Hazard	5	large trees, exposed roots, and leaning
Soil Type (*2)	4	sands and silts
Velocity (*2)	3	3.94 ft/s
Wave Action (Wind/Boat)	3	moderate, boats but 5 mph speed limit
Economic Factor (*2)	5	Sacramento
Human Usage	4	weekly, trails
Seepage Potential	0	no seepage history
Tidal Fluctuation	0	no tidal flux
Erosion Hazard	61	Calculate Erosion Hazard

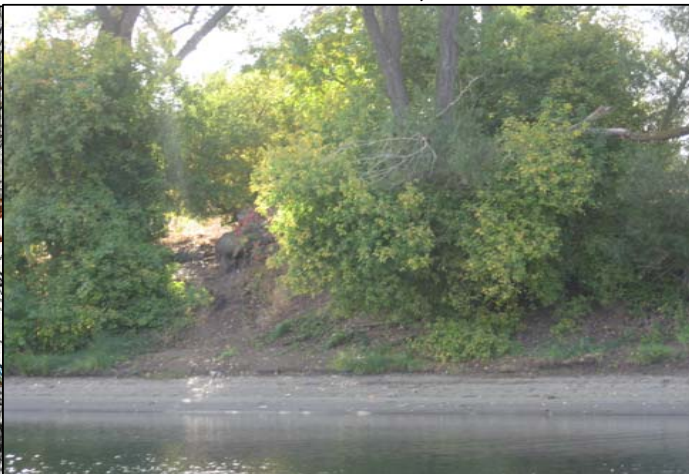
Site Photograph

Criteria	Score	Notes
Bank Slope (*2)	3	1.5:1 slope
Berm Width (*2) - Estimated	3	6 to 30 ft
Length of erosion	2	340 ft
Location of erosion	4	bank and toe
Bank Stability	0	no stability issues
Radius of Curvature (R_c/w)	0	$R/w = 5.16$
Site Relative to Bend	0	inside of a slight bend
Geomorph	0	no migration expected
Vegetation Cover	3	about 40 %
Tree Hazard	5	large trees with exposed roots, some leaning
Soil Type (*2)	4	sands and silts
Velocity (*2)	4	5.2 ft/s
Wave Action (Wind/Boat)	3	Near boat launch but 5 mph limit, moderate waves
Economic Factor (*2)	5	City of Sacramento
Human Usage	5	Bike path on top of levee, trails down, trash present, daily use
Seepage Potential	0	no history of seepage
Tidal Fluctuation	1	about 1 ft of tidal flux
Erosion Hazard	61	Calculate Erosion Hazard

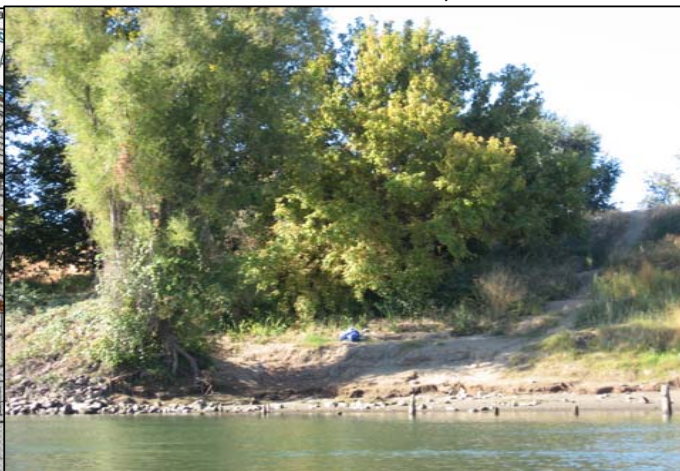
Site Photograph

Criteria	Score	Notes
Bank Slope (*2)	2	2:1 slope
Berm Width (*2) - Estimated	5	0 to 10 ft
Length of erosion	2	172 ft
Location of erosion	3	toe
Bank Stability	0	no vertical sections or caves
Radius of Curvature (R_c/w)	0	straight
Site Relative to Bend	1	straight
Geomorph	0	no migration expected
Vegetation Cover	1	70%
Tree Hazard	4	large trees with exposed roots
Soil Type (*2)	4	sands and silts
Velocity (*2)	4	5.02 ft/s
Wave Action (Wind/Boat)	4	heavy recreation area
Economic Factor (*2)	4	West Sacramento
Human Usage	5	daily
Seepage Potential	0	no seepage history
Tidal Fluctuation	2	2 ft of tidal flux
Erosion Hazard	60	Calculate Erosion Hazard

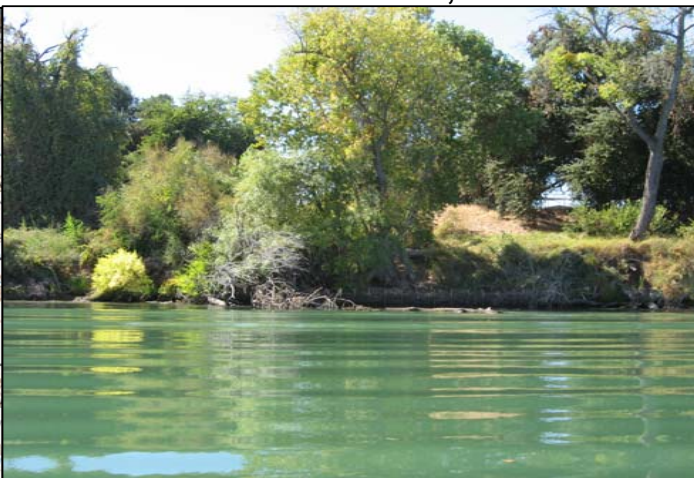
Site Photograph

Criteria	Score	Notes
Bank Slope (*2)	3	1.5:1 slope
Berm Width (*2) - Estimated	5	no berm
Length of erosion	4	1360 ft
Location of erosion	2	lower bank
Bank Stability	1	caves from fallen trees
Radius of Curvature (R_c/w)	0	straight
Site Relative to Bend	1	straight
Geomorph	0	tight levees, no migration
Vegetation Cover	1	60 to 70%
Tree Hazard	5	large trees with exposed roots and leaning
Soil Type (*2)	4	sands and silts
Velocity (*2)	4	5.08 ft/s
Wave Action (Wind/Boat)	3	moderate
Economic Factor (*2)	2	small town of Clarksburg
Human Usage	4	adjacent to road, pathway down, weekly
Seepage Potential	0	no seepage history
Tidal Fluctuation	3	3 ft of tidal flux
Erosion Hazard	60	Calculate Erosion Hazard

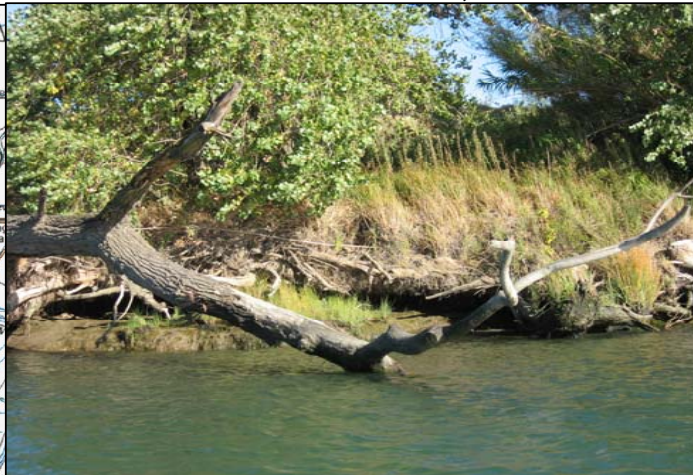
Site Photograph

Criteria	Score	Notes
Bank Slope (*2)	4	1:1 slope
Berm Width (*2) - Estimated	2	10 ft
Length of erosion	3	852 ft
Location of erosion	4	berm and toe
Bank Stability	5	caves, less than 4 ft, and vertical sections
Radius of Curvature (R_c/w)	0	straight
Site Relative to Bend	1	straight
Geomorph	0	no migration possible
Vegetation Cover	0	90%
Tree Hazard	5	large leaning trees, exposed roots
Soil Type (*2)	4	sands and silts
Velocity (*2)	3	4.54 ft/s
Wave Action (Wind/Boat)	4	heavy wind and boat area
Economic Factor (*2)	2	Small town is Isleton
Human Usage	4	weekly, path and picnic table
Seepage Potential	0	no seepage history
Tidal Fluctuation	4	4 ft of tidal flux
Erosion Hazard	60	Calculate Erosion Hazard

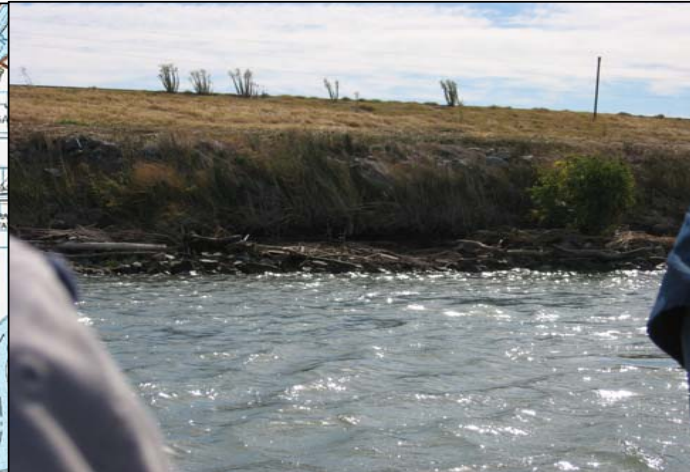
Site Photograph

Criteria	Score	Notes
Bank Slope (*2)	4	1:1 slope
Berm Width (*2) - Estimated	5	no berm
Length of erosion	2	400 ft
Location of erosion	1	mid bank
Bank Stability	2	vertical sections, less than half bank height
Radius of Curvature (R_c/w)	0	straight
Site Relative to Bend	1	straight
Geomorph	0	no migration expected
Vegetation Cover	3	varies, 30 to 60 %
Tree Hazard	0	no trees
Soil Type (*2)	4	sands and silts
Velocity (*2)	4	7.05 ft/s
Wave Action (Wind/Boat)	5	cargo ships pass by
Economic Factor (*2)	1	Farms
Human Usage	5	path and trash, daily
Seepage Potential	0	no history of seepage
Tidal Fluctuation	5	5 ft of tidal flux

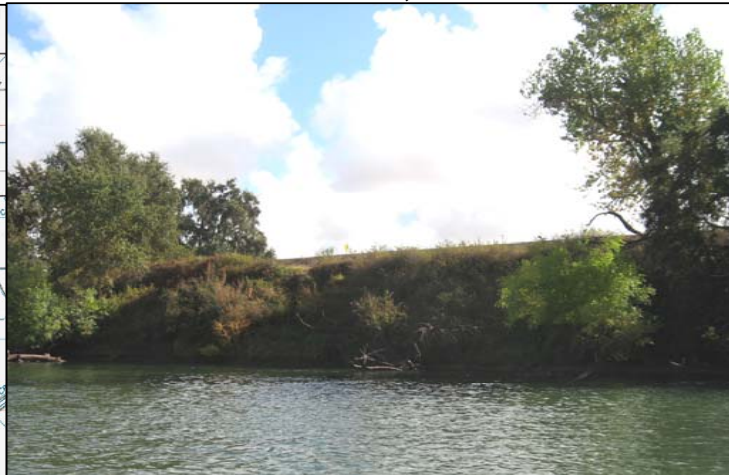
Site Photograph

Criteria	Score	Notes
Bank Slope (*2)	4	1:1 slope
Berm Width (*2) - Estimated	1	25 to 30 ft
Length of erosion	3	626 ft
Location of erosion	3	whole bank
Bank Stability	3	some holes from trees falling
Radius of Curvature (R_c/w)	0	straight
Site Relative to Bend	1	straight
Geomorph	2	migration possible on opposite bank
Vegetation Cover	1	70 to 80%
Tree Hazard	5	large trees with visible roots, some leaning
Soil Type (*2)	4	sands and silts
Velocity (*2)	4	7.08 ft/s
Wave Action (Wind/Boat)	3	moderate waves
Economic Factor (*2)	2	small town of Verona
Human Usage	4	adjacent to road, weekly use
Seepage Potential	5	history of seepage
Tidal Fluctuation	0	no tidal flux
Erosion Hazard	60	Calculate Erosion Hazard

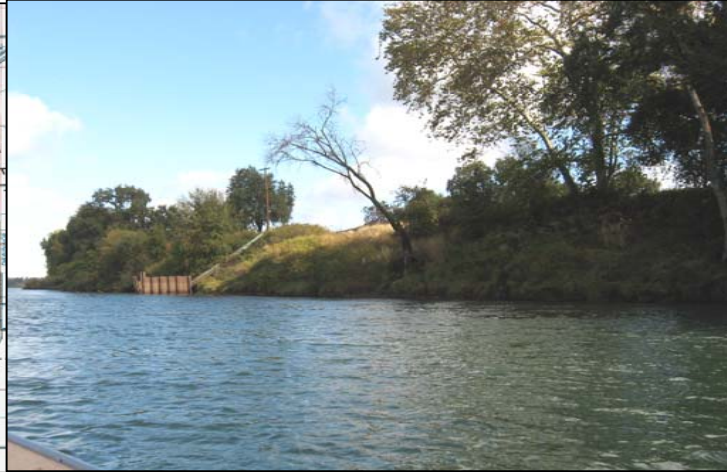
Site Photograph

Criteria	Score	Notes
Bank Slope (*2)	4	1:1 slope
Berm Width (*2) - Estimated	2	15 ft
Length of erosion	4	1052 ft
Location of erosion	5	toe and underwater
Bank Stability	2	vertical sections, less than half bank slope height
Radius of Curvature (R_c/w)	0	straight
Site Relative to Bend	1	straight
Geomorph	2	migration possible on opposite bank
Vegetation Cover	0	dense on bank, about 80%
Tree Hazard	4	trees with visible roots
Soil Type (*2)	4	sands and silts
Velocity (*2)	4	5.46 ft/s
Wave Action (Wind/Boat)		moderate wave
Economic Factor (*2)	2	town of Verona
Human Usage	5	frequent, trails down to bank
Seepage Potential	5	seepage history
Tidal Fluctuation	0	no tidal influence
Erosion Hazard	60	Calculate Erosion Hazard

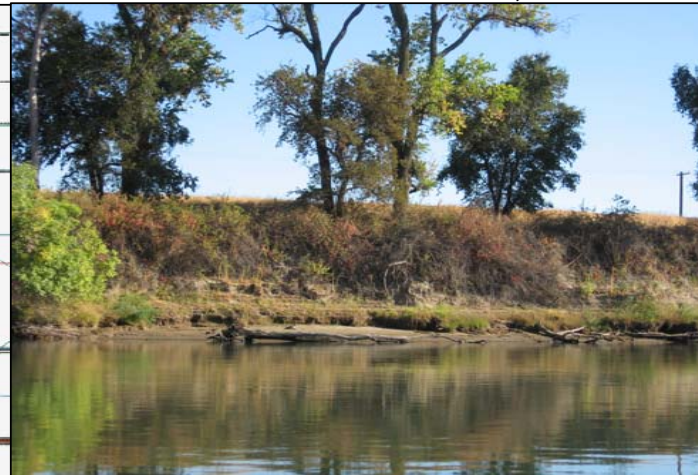
Site Photograph

Criteria	Score	Notes
Bank Slope (*2)	4	1:1 slope
Berm Width (*2) - Estimated	0	30 to 50 ft
Length of erosion	4	1065 ft
Location of erosion	2	full bank
Bank Stability	5	vertical sections, greater than half bank height and caves
Radius of Curvature (R_c/w)	0	straight
Site Relative to Bend	1	straight
Geomorph	0	no migration possible
Vegetation Cover	3	30%
Tree Hazard	3	large trees
Soil Type (*2)	2	clays and silts
Velocity (*2)	3	4.74 ft/s
Wave Action (Wind/Boat)	3	moderate
Economic Factor (*2)	5	Sacramento
Human Usage	4	weekly
Seepage Potential	5	seepage history
Tidal Fluctuation	1	1 ft of tidal flux

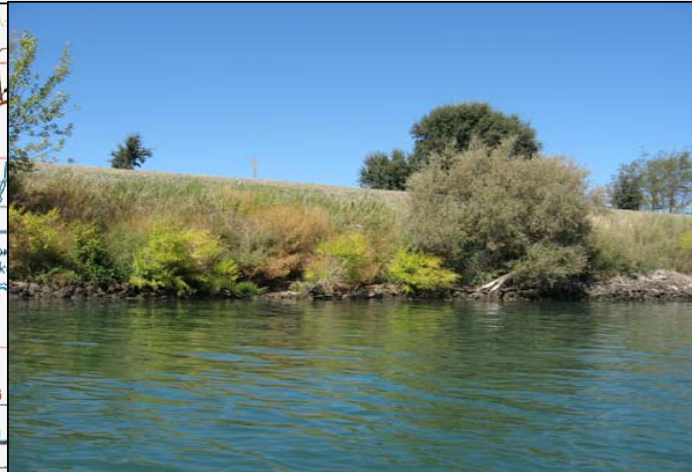
Site Photograph

Criteria	Score	Notes
Bank Slope (*2)	3	1.5:1 slope
Berm Width (*2) - Estimated	5	no berm
Length of erosion	2	499 ft
Location of erosion	4	toe
Bank Stability	5	vertical sections and caves
Radius of Curvature (R_c/w)	0	$R/w = 5.61$
Site Relative to Bend	0	inside of a bend
Geomorph	0	no migration possible
Vegetation Cover	1	70%
Tree Hazard	1	young trees
Soil Type (*2)	4	sands and silts
Velocity (*2)	4	6.52 ft/s
Wave Action (Wind/Boat)	3	moderate
Economic Factor (*2)	2	small town of Courtland
Human Usage	4	weekly
Seepage Potential	0	no seepage expected
Tidal Fluctuation	3	3 ft of tidal flux

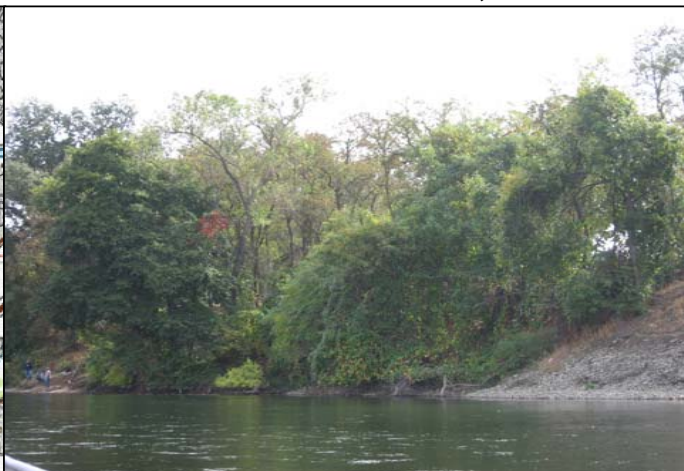
Site Photograph

Criteria	Score	Notes
Bank Slope (*2)	3	1.5:1 slope
Berm Width (*2) - Estimated	2	10 to 15 ft
Length of erosion	2	500 ft
Location of erosion	2	lower bank
Bank Stability	2	vertical sections, less than half bank height
Radius of Curvature (R_c/w)	0	straight
Site Relative to Bend	1	straight
Geomorph	0	no migration expected
Vegetation Cover	1	60%
Tree Hazard	5	large trees, some exposed roots, some leaning
Soil Type (*2)	4	sands and silts
Velocity (*2)	5	8.74 ft/s
Wave Action (Wind/Boat)	3	moderate, boats but 5 mph speed limit
Economic Factor (*2)	5	Sacramento
Human Usage	5	daily, people on banks, lots of trash and paths
Seepage Potential	0	no seepage history
Tidal Fluctuation	0	no tidal flux

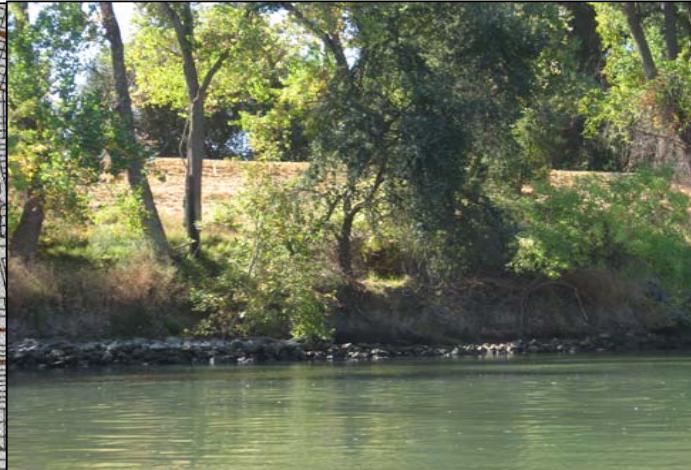
Site Photograph

Criteria	Score	Notes
Bank Slope (*2)	2	2:1 slope
Berm Width (*2) - Estimated	5	0 to 15 ft
Length of erosion	3	664 ft
Location of erosion	3	toe
Bank Stability	1	caves from tree popouts
Radius of Curvature (R_c/w)	0	$R/w = 6.98$
Site Relative to Bend	1	relatively straight
Geomorph	0	no migration possible
Vegetation Cover	1	70 to 80%
Tree Hazard	4	large trees with exposed roots
Soil Type (*2)	4	sands and silts
Velocity (*2)	3	4.5 ft/s (UNET)
Wave Action (Wind/Boat)	3	moderate boating
Economic Factor (*2)	5	Sacramento
Human Usage	2	seasonal
Seepage Potential	0	no seepage history
Tidal Fluctuation	2	2 ft of tidal flux
Erosion Hazard	58	Calculate Erosion Hazard

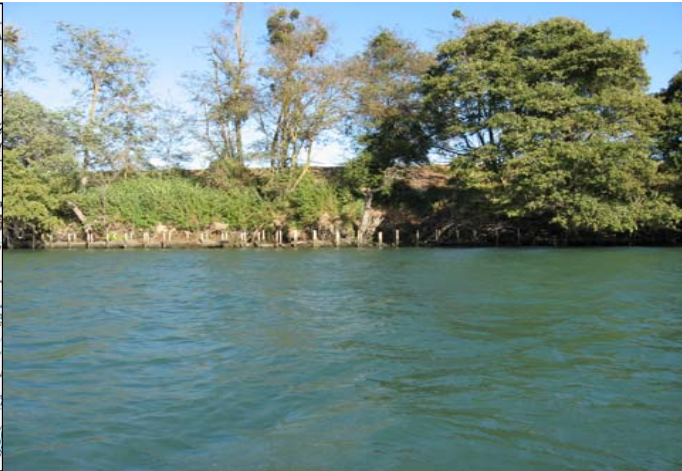
Site Photograph

Criteria	Score	Notes
Bank Slope (*2)	4	1:1 slope
Berm Width (*2) - Estimated	2	10 ft
Length of erosion	3	589 ft
Location of erosion	2	berm
Bank Stability	5	short vertical sections and caves
Radius of Curvature (R_c/w)	0	straight
Site Relative to Bend	1	straight
Geomorph	0	no migration possible
Vegetation Cover	1	60 to 70 %
Tree Hazard	4	medium trees, exposed roots
Soil Type (*2)	4	sands and silts
Velocity (*2)	3	4.16 ft/s
Wave Action (Wind/Boat)	4	heavy wind and boats
Economic Factor (*2)	2	small town of Isleton
Human Usage	4	weekly, path down
Seepage Potential	0	no seepage history
Tidal Fluctuation	4	4 ft of tidal flux
Erosion Hazard	58	Calculate Erosion Hazard

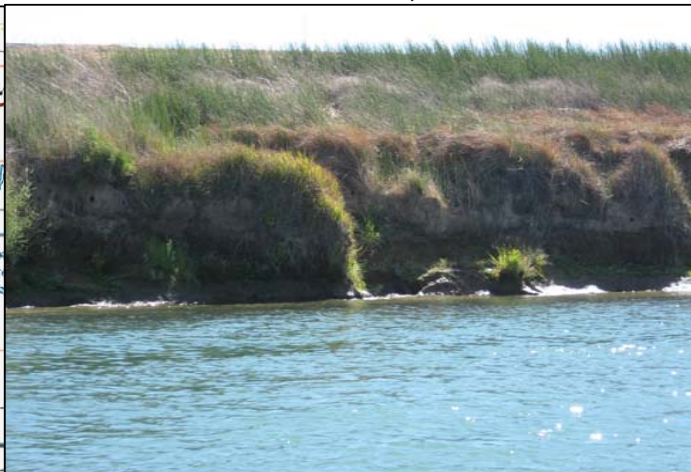
Site Photograph

Criteria	Score	Notes
Bank Slope (*2)	2	2:1 slope
Berm Width (*2) - Estimated	5	no berm
Length of erosion	2	330 ft
Location of erosion	5	toe and underwater
Bank Stability	4	vertical sections greater than half bank height
Radius of Curvature (R_c/w)	0	$R/w = 5.61$
Site Relative to Bend	3	outside of a greater than 90 degree bend
Geomorph	0	no migration possible
Vegetation Cover	2	50%
Tree Hazard	1	lone small tree
Soil Type (*2)	4	sands and silts
Velocity (*2)	4	6.52 ft/s
Wave Action (Wind/Boat)	3	moderate
Economic Factor (*2)	1	Farms
Human Usage	1	steep sections, occasional usage
Seepage Potential	0	no seepage expected
Tidal Fluctuation	3	3 ft of tidal flux

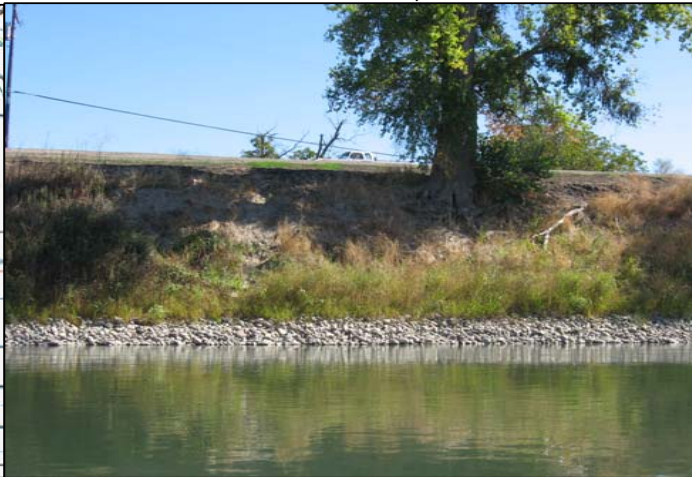
Site Photograph

Criteria	Score	Notes
Bank Slope (*2)	3	1.5:1 slope
Berm Width (*2) - Estimated	5	0 to 60 ft
Length of erosion	2	337 ft
Location of erosion	4	berm slope and toe
Bank Stability	0	no vertical sections or caves
Radius of Curvature (R_c/w)	4	$R/w = 1.22$
Site Relative to Bend	5	outside of a tight bend
Geomorph	2	migration possible on opposite bank
Vegetation Cover	2	50%
Tree Hazard	4	large trees with exposed roots
Soil Type (*2)	2	clays and silts
Velocity (*2)	2	2.86 ft/s
Wave Action (Wind/Boat)	2	moderate
Economic Factor (*2)	2	small town of Meridian
Human Usage	2	seasonal
Seepage Potential	0	no seepage history
Tidal Fluctuation	0	no tidal influence
Erosion Hazard	55	Calculate Erosion Hazard

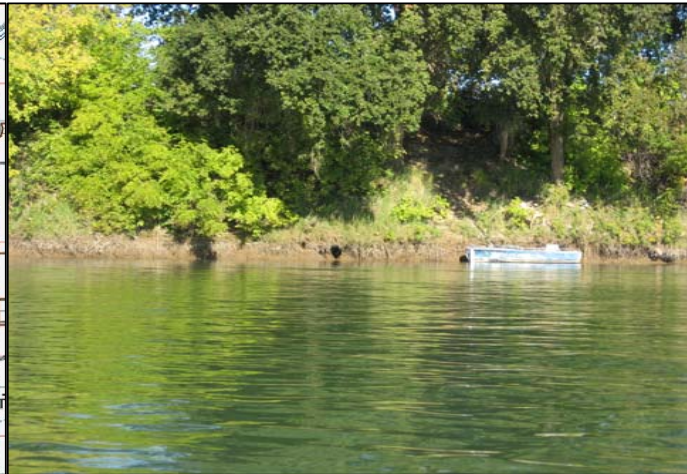
Site Photograph

Criteria	Score	Notes
Bank Slope (*2)	3	1.5:1 slope
Berm Width (*2) - Estimated	0	35 ft
Length of erosion	2	468 ft
Location of erosion	3	toe
Bank Stability	5	vertical sections less than half bank height and caves
Radius of Curvature (R_c/w)	0	$R/w = 6.31$
Site Relative to Bend	3	outside of a gentle bend
Geomorph	0	no migration expected
Vegetation Cover	1	60 - 70%
Tree Hazard	3	large trees
Soil Type (*2)	4	sands and silts
Velocity (*2)	3	4.82 ft/s
Wave Action (Wind/Boat)	2	low, marina with wake restrictions
Economic Factor (*2)	5	Sacramento
Human Usage	0	rare
Seepage Potential	5	history of seepage
Tidal Fluctuation	1	1 ft of tidal flux
Erosion Hazard	55	Calculate Erosion Hazard

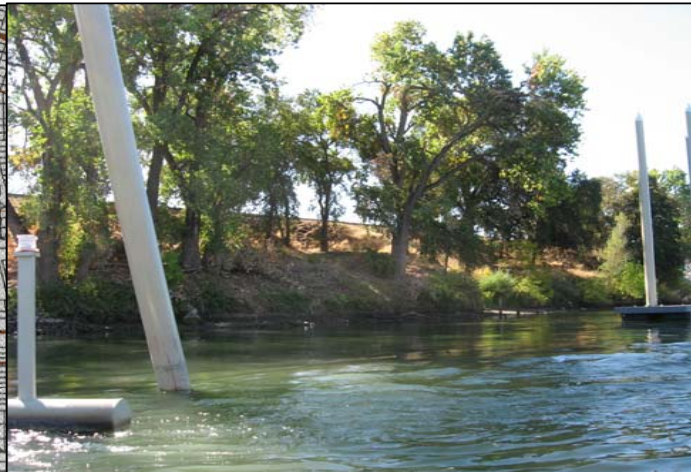
Site Photograph

Criteria	Score	Notes
Bank Slope (*2)	3	1.5:1 slope
Berm Width (*2) - Estimated	2	15 ft
Length of erosion	2	312 ft
Location of erosion	2	levee slope
Bank Stability	2	small vertical section
Radius of Curvature (R_c/w)	0	relatively straight
Site Relative to Bend	1	relatively straight
Geomorph	0	no migration possible
Vegetation Cover	2	40%
Tree Hazard	3	large trees
Soil Type (*2)	4	sands and silts
Velocity (*2)	3	4.84 ft/s
Wave Action (Wind/Boat)	2	low, no wake zone
Economic Factor (*2)	5	Sacramento
Human Usage	5	paths and human debris, adjacent to hotel
Seepage Potential	0	no seepage history
Tidal Fluctuation	2	2 ft of tidal flux
Erosion Hazard	55	Calculate Erosion Hazard

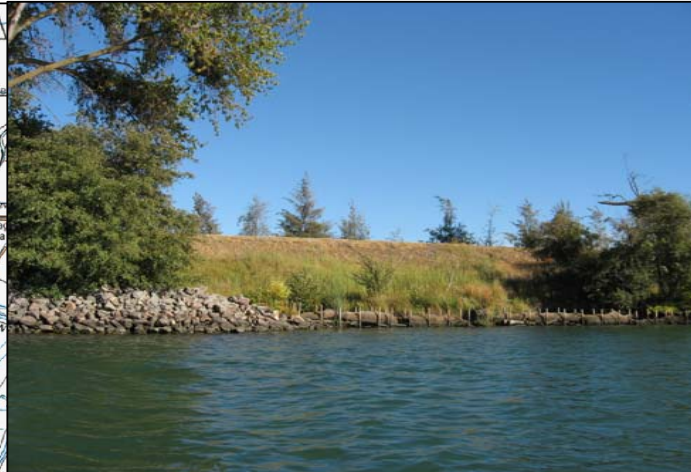
Site Photograph

Criteria	Score	Notes
Bank Slope (*2)	3	1.5:1 slope
Berm Width (*2) - Estimated	5	no berm
Length of erosion	2	311 ft
Location of erosion	2	berm
Bank Stability	4	vertical sections greater than half bank height
Radius of Curvature (R_c/w)	0	straight
Site Relative to Bend	1	straight
Geomorph	0	no migration possible
Vegetation Cover	0	90%
Tree Hazard	3	large trees, one already fallen
Soil Type (*2)	4	sands and silts
Velocity (*2)	3	4.82 ft/s
Wave Action (Wind/Boat)	4	heavy winds and boating
Economic Factor (*2)	2	small town of Isleton
Human Usage	1	occassional
Seepage Potential	0	no seepage
Tidal Fluctuation	4	4 ft of tidal flux
Erosion Hazard	55	Calculate Erosion Hazard

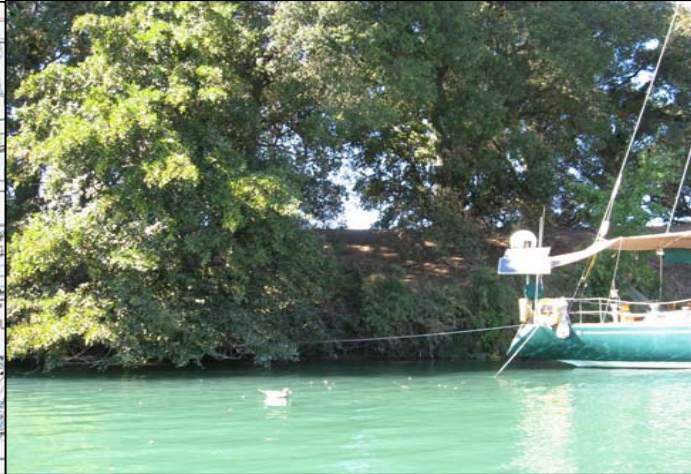
Site Photograph

Criteria	Score	Notes
Bank Slope (*2)	3	1.5:1 slope
Berm Width (*2) - Estimated	5	no berm
Length of erosion	1	100 ft
Location of erosion	4	toe and lower bank
Bank Stability	2	vertical sections
Radius of Curvature (R_c/w)	2	$R/w = 3.5$
Site Relative to Bend	3	outside of slight bend
Geomorph	0	no migration expected
Vegetation Cover	1	60 - 70%
Tree Hazard	4	large trees, exposed roots
Soil Type (*2)	2	clays and silts
Velocity (*2)	3	4.87 ft/s
Wave Action (Wind/Boat)	3	moderate
Economic Factor (*2)	1	Farms
Human Usage	3	monthly
Seepage Potential	0	no known seepage history
Tidal Fluctuation	4	roughly 4 ft of tidal influence
Erosion Hazard	55	Calculate Erosion Hazard

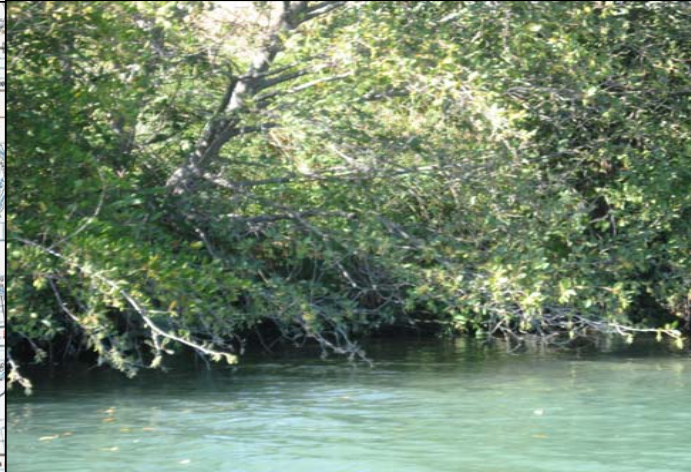
Site Photograph

Criteria	Score	Notes
Bank Slope (*2)	4	1:1 or less
Berm Width (*2) - Estimated	3	5 ft
Length of erosion	3	673 ft
Location of erosion	4	toe and bank
Bank Stability	2	vertical sections, less than half bank height
Radius of Curvature (R_c/w)	0	straight
Site Relative to Bend	1	straight
Geomorph	0	no migration possible
Vegetation Cover	2	60%
Tree Hazard	4	large trees, exposed roots
Soil Type (*2)	4	sands and silts
Velocity (*2)	3	3.88 ft/s
Wave Action (Wind/Boat)	3	moderate wind and boat wake
Economic Factor (*2)	1	Farms
Human Usage	2	seasonal
Seepage Potential	0	no seepage history
Tidal Fluctuation	4	4 ft of tidal flux

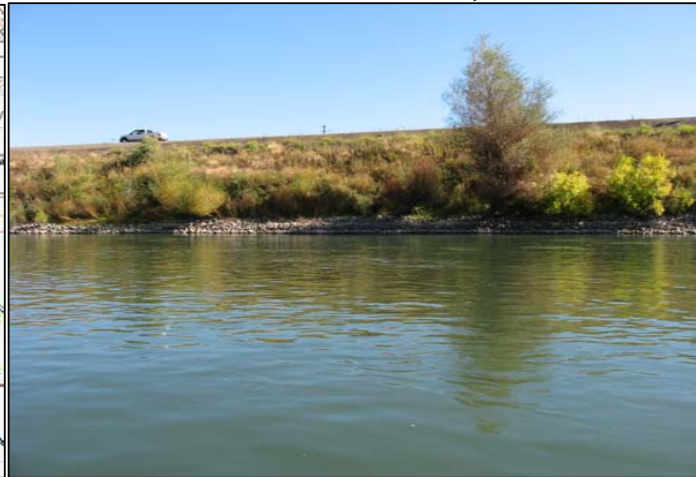
Site Photograph

Criteria	Score	Notes
Bank Slope (*2)	4	1:1 slope
Berm Width (*2) - Estimated	5	no berm
Length of erosion	4	1242 ft
Location of erosion	4	toe and lower bank
Bank Stability	2	vertical section, less than half bank height
Radius of Curvature (R_c/w)	2	$R/w = 2.3$
Site Relative to Bend	3	outside of gentle bend
Geomorph	2	slight migration possible on opposite bank
Vegetation Cover	1	75%
Tree Hazard	0	no trees
Soil Type (*2)	2	clays and silts
Velocity (*2)	2	2.58 ft/s
Wave Action (Wind/Boat)	3	moderate
Economic Factor (*2)	2	small town of Meridian
Human Usage	3	monthly
Seepage Potential	0	no seepage history
Tidal Fluctuation	0	no tidal influence
Erosion Hazard	54	Calculate Erosion Hazard

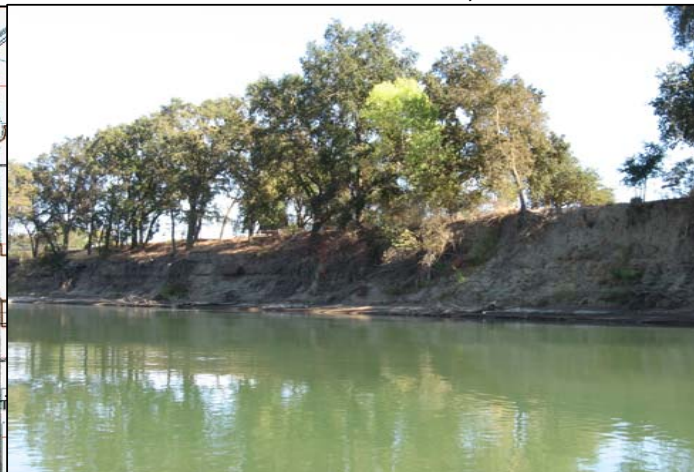
Site Photograph

Criteria	Score	Notes
Bank Slope (*2)	5	vertical bank
Berm Width (*2) - Estimated	0	40 to 50 ft
Length of erosion	2	474 ft
Location of erosion	3	full bank
Bank Stability	5	beaver burrows and vertical bank
Radius of Curvature (R_c/w)	2	$R/w = 3.4$
Site Relative to Bend	2	just downstream of a bend
Geomorph	3	slight migration possible on erosion side
Vegetation Cover	4	10%
Tree Hazard	5	large trees with exposed roots and leaning
Soil Type (*2)	4	sands and silts
Velocity (*2)	2	2.15 ft/s
Wave Action (Wind/Boat)	3	moderate, recreation area
Economic Factor (*2)	0	Would go into the Yolo Bypass
Human Usage	3	monthly, trail but not easy to access
Seepage Potential	0	no seepage history
Tidal Fluctuation	0	no tidal influence

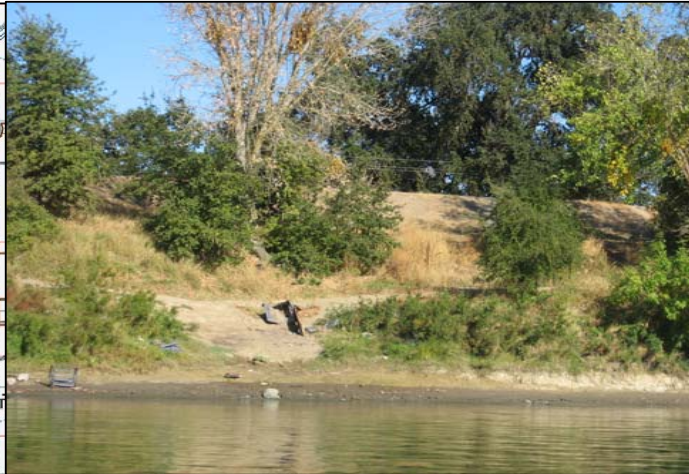
Site Photograph

Criteria	Score	Notes
Bank Slope (*2)	1	2.5:1 slope
Berm Width (*2) - Estimated	2	15 ft
Length of erosion	3	654 ft
Location of erosion	3	toe
Bank Stability	0	no vertical sections or caves
Radius of Curvature (R_c/w)	0	straight
Site Relative to Bend	1	straight
Geomorph	0	no migration expected
Vegetation Cover	1	80%
Tree Hazard	3	large trees
Soil Type (*2)	4	sands and silts
Velocity (*2)	3	4.89 ft/s
Wave Action (Wind/Boat)	2	low
Economic Factor (*2)	5	Sacramento
Human Usage	5	daily, road and lots of human debris
Seepage Potential	5	history of seepage
Tidal Fluctuation	1	1 ft of tidal flux
Erosion Hazard	54	Calculate Erosion Hazard

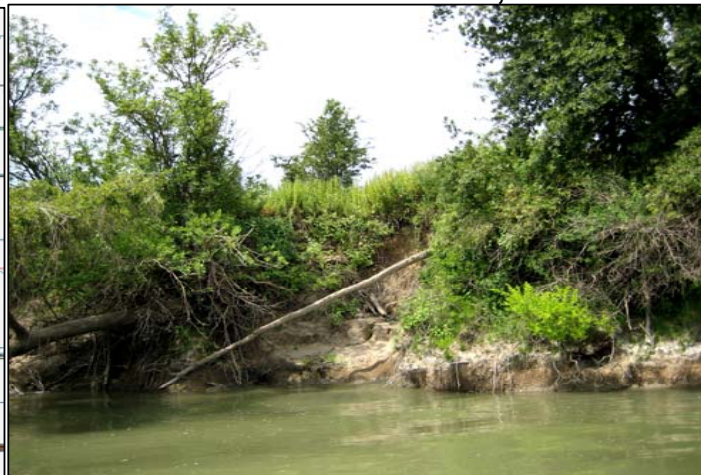
Site Photograph

Criteria	Score	Notes
Bank Slope (*2)	4	1:1 slope
Berm Width (*2) - Estimated	1	25 ft
Length of erosion	3	522 ft
Location of erosion	4	berm and toe
Bank Stability	5	vertical sections, greater than half bank height and animal burrows
Radius of Curvature (R_c/w)	0	straight
Site Relative to Bend	1	straight
Geomorph	0	no migration possible
Vegetation Cover	2	50%
Tree Hazard	5	trees with exposed roots and leaning
Soil Type (*2)	4	sands and silts
Velocity (*2)	4	5.05 ft/s
Wave Action (Wind/Boat)	3	moderate
Economic Factor (*2)	1	Farms
Human Usage	2	seasonal
Seepage Potential	0	no seepage history
Tidal Fluctuation	1	1 ft of tidal flux
Erosion Hazard	54	Calculate Erosion Hazard

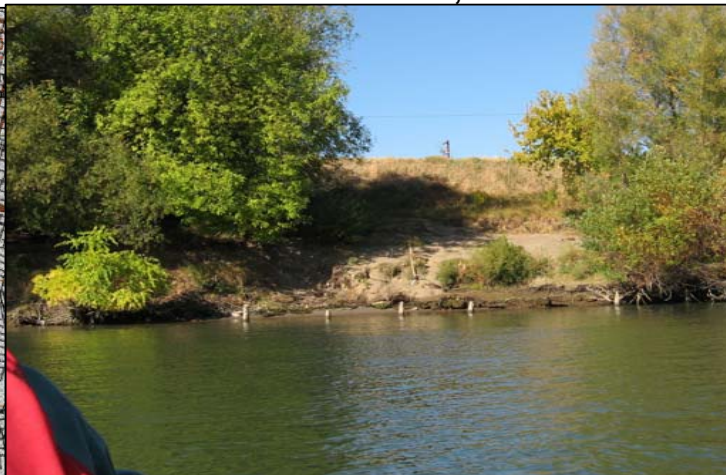
Site Photograph

Criteria	Score	Notes
Bank Slope (*2)	3	1.5:1 slope
Berm Width (*2) - Estimated	0	30 to 40 ft
Length of erosion	2	400 ft
Location of erosion	4	lower bank and toe
Bank Stability	2	short vertical sections
Radius of Curvature (R_c/w)	0	straight
Site Relative to Bend	1	straight
Geomorph	0	no migration possible
Vegetation Cover	2	60%
Tree Hazard	4	large trees with exposed roots
Soil Type (*2)	4	sands and silts
Velocity (*2)	3	4.88 ft/s
Wave Action (Wind/Boat)	4	heavy recreation area
Economic Factor (*2)	4	West Sacramento
Human Usage	5	daily
Seepage Potential	0	no known history
Tidal Fluctuation	2	2 ft of tidal flux

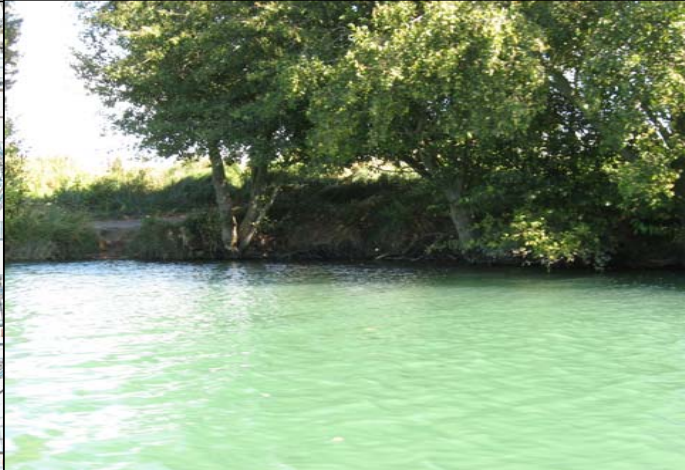
Site Photograph

Criteria	Score	Notes
Bank Slope (*2)	3	1.5:1 slope
Berm Width (*2) - Estimated	4	less than 5 ft
Length of erosion	4	1138 ft
Location of erosion	3	toe
Bank Stability	4	vertical sections
Radius of Curvature (R_c/w)	0	straight
Site Relative to Bend	1	straight
Geomorph	0	no migration possible
Vegetation Cover	0	85%
Tree Hazard	5	trees with exposed roots and leaning
Soil Type (*2)	4	sands and silts
Velocity (*2)	3	3.94 ft/s
Wave Action (Wind/Boat)	3	moderate
Economic Factor (*2)	1	Farms
Human Usage	0	too steep for access
Seepage Potential	0	no seepage history
Tidal Fluctuation	4	4 ft of tidal flux

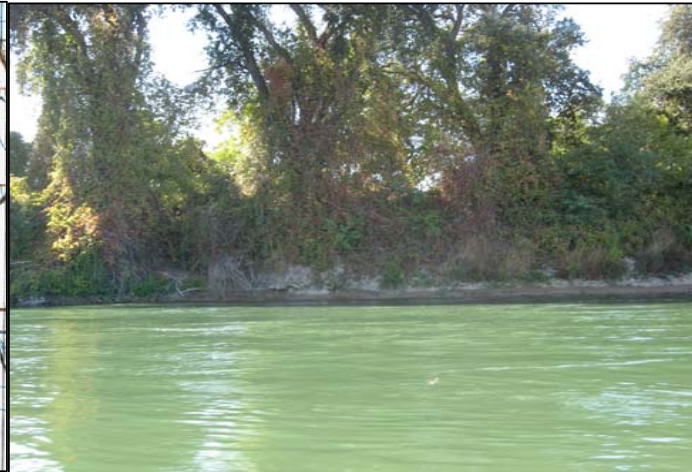
Site Photograph

Criteria	Score	Notes
Bank Slope (*2)	4	less than 1:1 slope, near vertical
Berm Width (*2) - Estimated	0	50 ft
Length of erosion	2	488 ft
Location of erosion	4	full bank and toe
Bank Stability	5	vertical sections and some animal holes
Radius of Curvature (R_c/w)	1	$R/w = 4.4$
Site Relative to Bend	3	outside of a gentle bend
Geomorph	5	migration possible on both banks
Vegetation Cover	1	70 to 80%
Tree Hazard	4	large trees with exposed roots
Soil Type (*2)	2	clays and silts
Velocity (*2)	4	5.69 ft/s
Wave Action (Wind/Boat)	2	low
Economic Factor (*2)	3	rural town of Colusa
Human Usage	0	rare
Seepage Potential	0	no seepage history
Tidal Fluctuation	0	no tidal influence

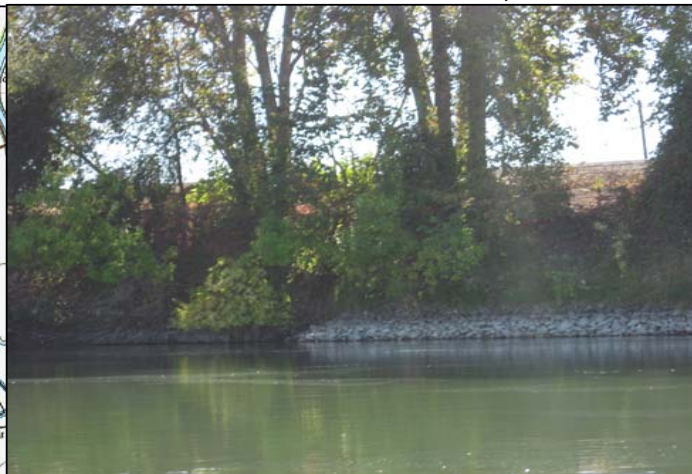
Site Photograph

Criteria	Score	Notes
Bank Slope (*2)	4	1.5:1 slope
Berm Width (*2) - Estimated	1	25 30 ft
Length of erosion	3	576 ft
Location of erosion	5	toe and underwater
Bank Stability	2	vertical sections, less than half bank height
Radius of Curvature (R_c/w)	0	straight
Site Relative to Bend	1	straight
Geomorph	0	no migration expected
Vegetation Cover	3	30%
Tree Hazard	5	large trees, roots exposed and leaning
Soil Type (*2)	4	sands and silts
Velocity (*2)	3	3.18 ft/s
Wave Action (Wind/Boat)	2	moderate
Economic Factor (*2)	2	small town of Knight's landing
Human Usage	4	weekly, trail to bank
Seepage Potential	0	no history of seepage
Tidal Fluctuation	0	no tidal influence

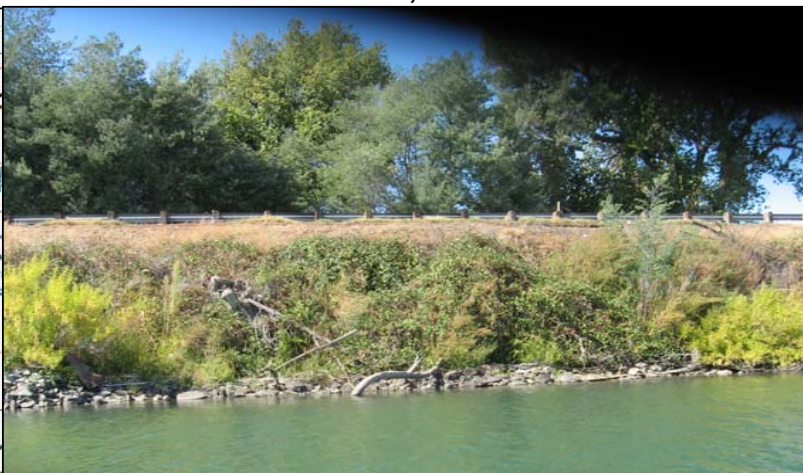
Site Photograph

Criteria	Score	Notes
Bank Slope (*2)	3	1.5:1 slope
Berm Width (*2) - Estimated	5	no berm
Length of erosion	2	183 ft
Location of erosion	2	full bnak
Bank Stability	0	no vertical sections or caves
Radius of Curvature (R_c/w)	0	$R/w = 5.61$
Site Relative to Bend	3	outside of a greater than 90 degree bend
Geomorph	0	no migration possible
Vegetation Cover	1	60%
Tree Hazard	0	no trees
Soil Type (*2)	4	sands and silts
Velocity (*2)	4	5.89 ft/s
Wave Action (Wind/Boat)	3	moderate
Economic Factor (*2)	1	Farms
Human Usage	5	daily
Seepage Potential	0	no seepage expected
Tidal Fluctuation	3	3 ft of tidal flux
